# **Libertyville Wetland Mitigation Bank**

## **Third Annual Monitoring Report**

**2008**

## **Libertyville Tidal Wetland Bank**

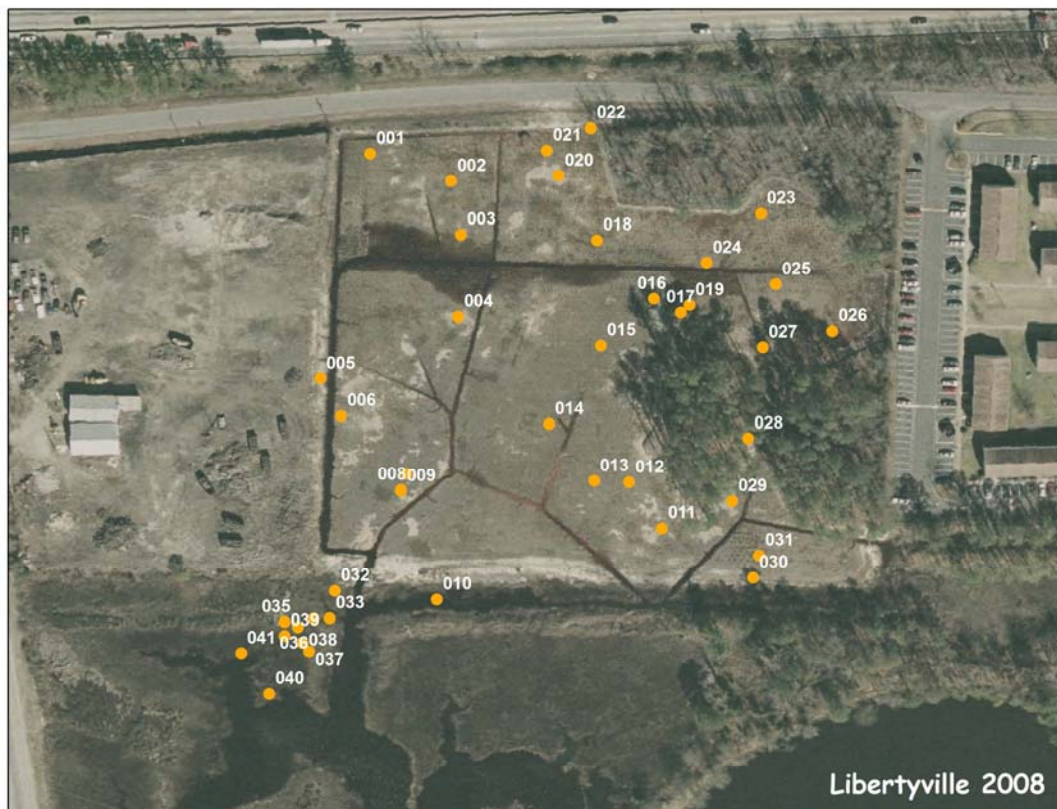
Fig. 4 Quadrat locations

GPS points and spot elevations were collected for each of the quadrats sampled and are presented in Figure 4.
