A Sustainable Chesapeake

CHAPTER (2) STREAM RESTORATION

A "Hard" Design Approach to Stream Restoration

Making the Most of Confined Spaces in Baltimore's Stony Run

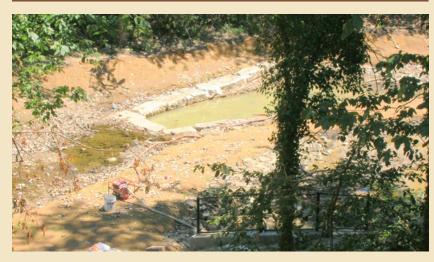
CROSS VANE ENGINEERING SCHEMATIC AND PHOTO

- > Cross Vanes: Cross vanes act as grade control structures that reduce near-bank shear stress, velocity, and stream power, but increases the energy in the center of the channel. Cross vanes contribute to water quality improvement by reducing flow velocities and creating habitat for aquatic species via downstream pools.

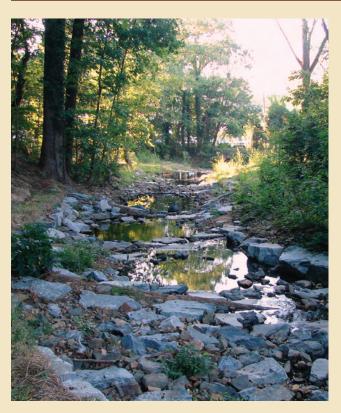
STEP-POOL ENGINEERING SCHEMATIC AND PHOTO

- > Step-Pool Sequences: Step pools result from a series of steps constructed from natural materials (rock, imbricated rip-rap, wood, or concrete) longitudinally through a stream reach. Step-pools can be shallow or deep. They contribute to water quality improvement by increasing hydrodynamic diversity, lowering stream velocity, and creating habitat.

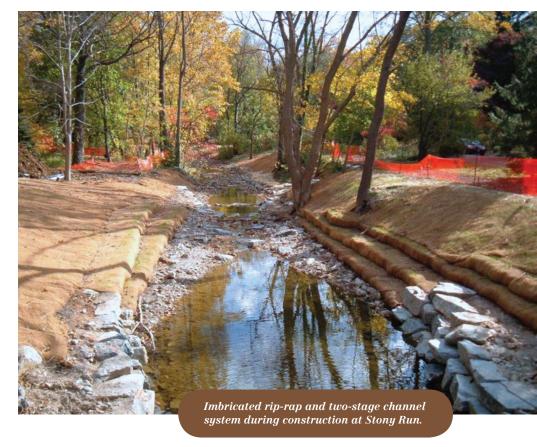
- ➤ Imbricated Rip-Rap: Imbricated rip-rap involves large, overlapping durable materials (usually rocks) used to protect a stream bank from erosion. A study of the Minebank Run stream restoration in Baltimore found that a restored reach designed after the Rosgen Method and using high armored banks had higher denitrification rates than the unrestored sites. However, denitrification rates were even higher at low-bank sites where the stream was connected to the adjacent floodplain.¹⁹ Minebank Run is a second-order stream with 30 to 35% of its watershed covered by impervious surface.
- Plunge Pools: Plunge pools are simply basins used to slow flowing water. A small, deep plunge pool

dissipates energy as water enters the pool from its upland source. Beyond reducing flow velocities, plunge pools create habitats for aquatic species. There is little question about the effectiveness of plunge pools as they have been used for many years as an important water management technique.

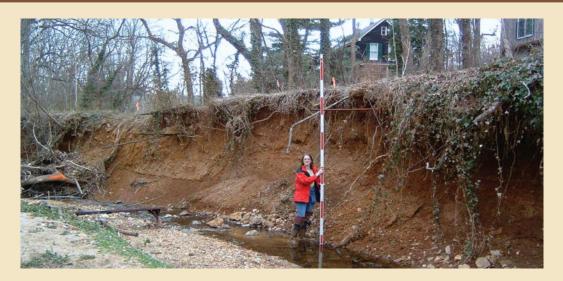
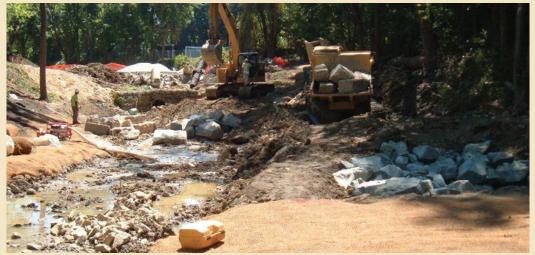
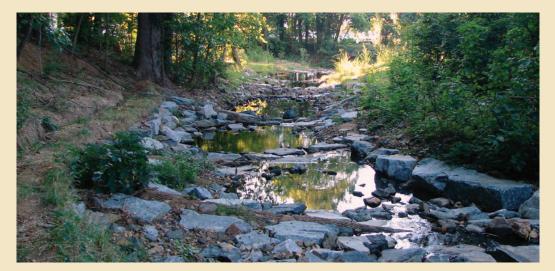
STONY RUN RESTORATION SEQUENCE

S tony Run showing pre-construction stream bank erosion (top); stream re-construction under way (middle); and a recent image of the streambed (bottom).
