# A Sustainable Chesapeake

## A "Seepage Wetland" Design Approach to Stream Restoration

A Better Model for Urban Stormwater Management in Wilelinor Stream Watershed

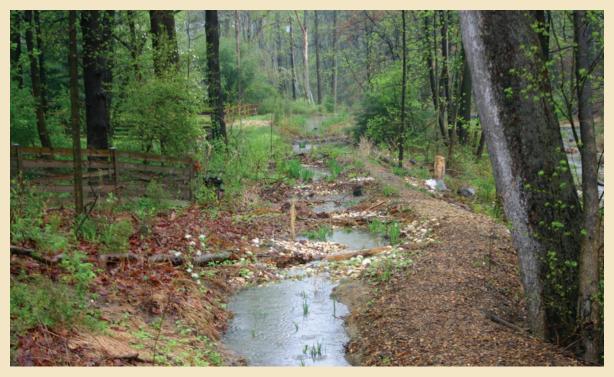
A see page reservoir at Wilelinor Stream. The main stream channel is to the right.

Seepage Reservoirs: Seepage reservoirs are containment areas alongside streams where water is stored temporarily to dissipate energy from storm events; water may then exfiltrate from an area of higher elevation into the stream channel. Seepage reservoirs replicate functions occurring in natural riparian zones, such as dissipation of water energy and denitrification. A study of the denitrification potential in four urban and four rural riparian zones in the Baltimore metropolitan area demonstrated "strong positive relationships between soil moisture and organic matter content and denitrification potential."13

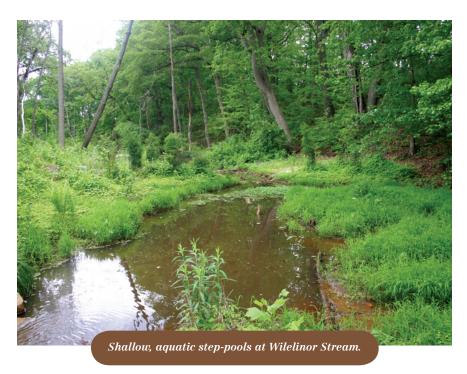
**Sequences:** These pools are created with the placement of a riffle weir grade control structure in a watercourse. Nitrogen removal can be

increased by step pools such as these because they "increase topographic complexity, surface-to-area-volume ratio, and hydraulic retention to allow for greater contact between the water and the benthos (e.g., introduction of large, woody debris, construction of pool-riffle or step-pool sequences)." Using step pools to slow and retain water may even be one of the best options for urban headwater streams. 19,20
