A Sustainable Chesapeake

A "Soft" Design Approach to Stream Restoration

Riparian Buffers at Work in the Urban Watershed of Alexandria's Kingstowne Stream

Kingstowne Stream Restoration Fairfax County, Virginia

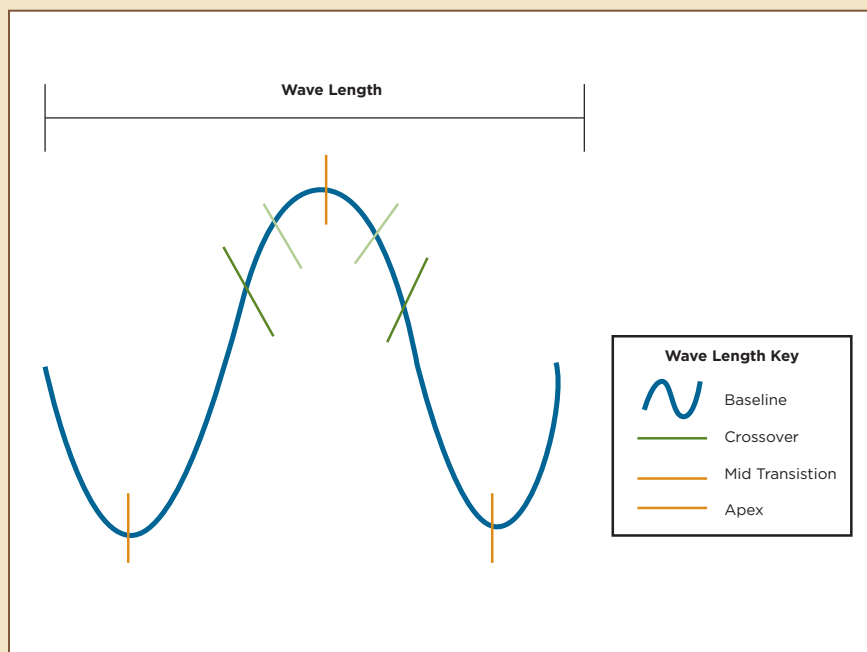
KINGSTOWNE STREAM RESTORATION MEANDER SCHEMATIC

Note: This drawing is a representation of the actual stream cross section restoration and is not to scale. This pattern is repeated through the length of the restoration project.

This schematic drawing represents a plan view of the meander pattern repeated at Kingstowne Stream restoration. The "crossover," "mid-transition" and "apex" segments of the restoration plan have engineering specifications and cross section drawings that give detailed information about how grading and slopes, substrate composition, rock placement, riparian plantings and other features should be configured.

► **Soft Meanders:** Meanders are bends that give a snake-like appearance to the reach of a stream. A stream reach is said to be meandering if its length is at least 1.5 times the length of the valley through which it passes. Any reach that exceeds the length of the valley can be taken as evidence of meandering, but 1.5 is the standard minimum used to confirm meandering activity. As with plunge pools and detention ponds, the key water quality functions of soft meanders are delivered through the lower flow velocity. The Kingstowne stream restoration plan called for a greater meander ratio than the existing stream and added measures to stabilize the bank and streambed.

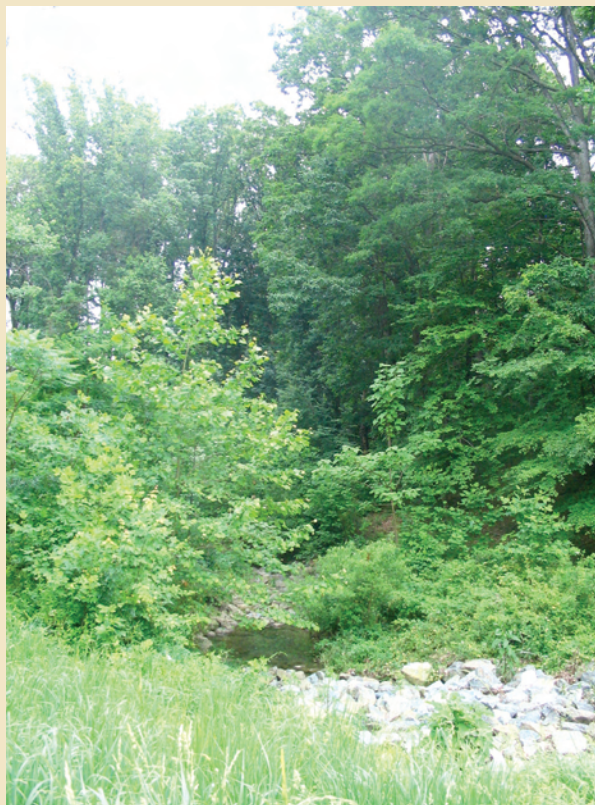
KINGSTOWNE STREAM RIPARIAN BUFFER PHOTO AND SCHEMATIC

A 30-meter (100-foot) buffer width can provide very good control of nitrogen, including nitrate, and trap sediments under most circumstances.¹⁶ The Kingstowne Stream restoration has the largest riparian buffer of the three case studies presented in this publication, with an average width of 268 feet. Wider buffer widths of 100-300 feet provide greater habitat benefits for a variety of wildlife.

- ▶ **Riparian Buffers:** Riparian buffers are generally defined as areas containing plants and other organisms adjacent to water. A swath of riparian vegetation along a channel bank provides some measure of protection from the erosive forces of water flowing through the stream valley and along the channel margins. It may also lower stream temperature and reduce sediment and nutrient transport. A 30-meter (100-foot) buffer width can provide very good control of nitrogen, including nitrate, and trap sediments under most circumstances.¹⁷ The Kingstowne Stream restoration has the largest riparian buffer of the three case studies presented in this publication, with an average width of 268 feet.
